## GPR CONCRETE SCANNING REPORT

Date: 01/09/26 Time: 7:00am-2:00pm Report: 1814

GPR Examination of: Concrete Culverts

### GPR REINFORCEMENT SURVEY – PRECAST CULVERTS

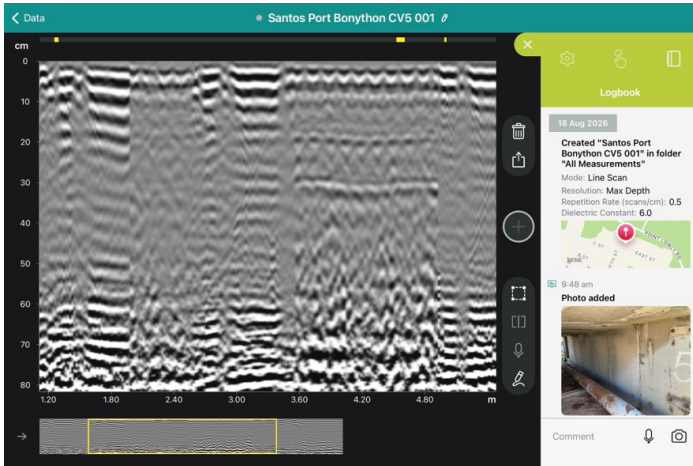
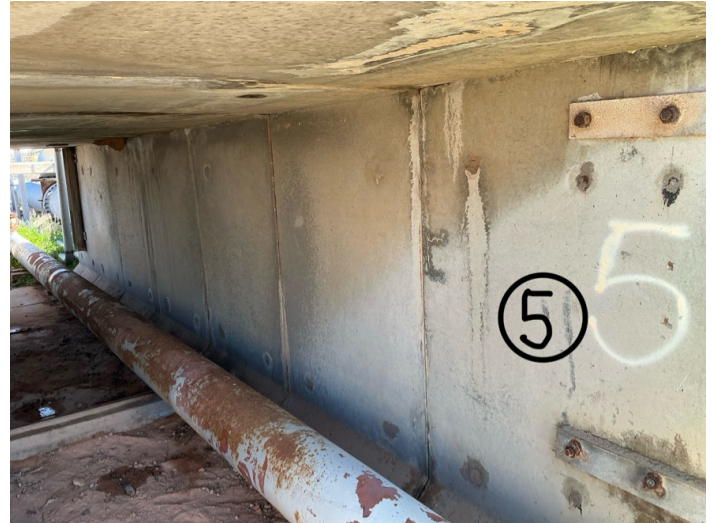
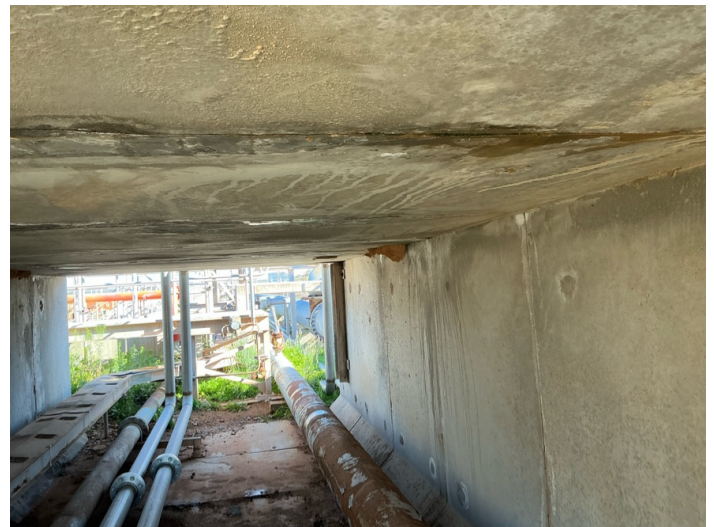
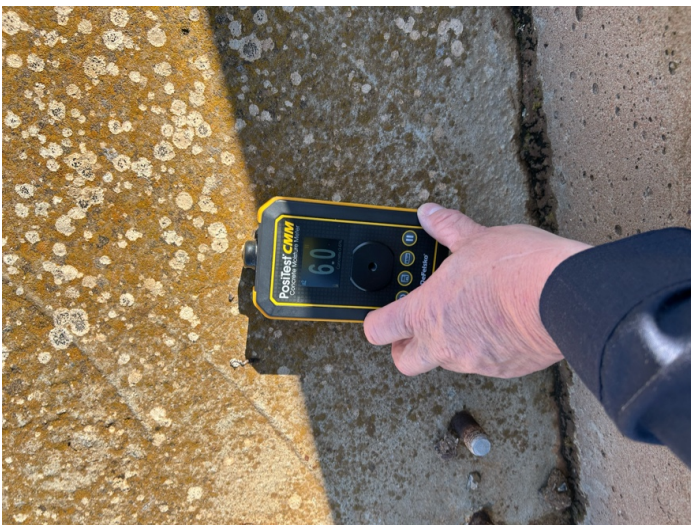
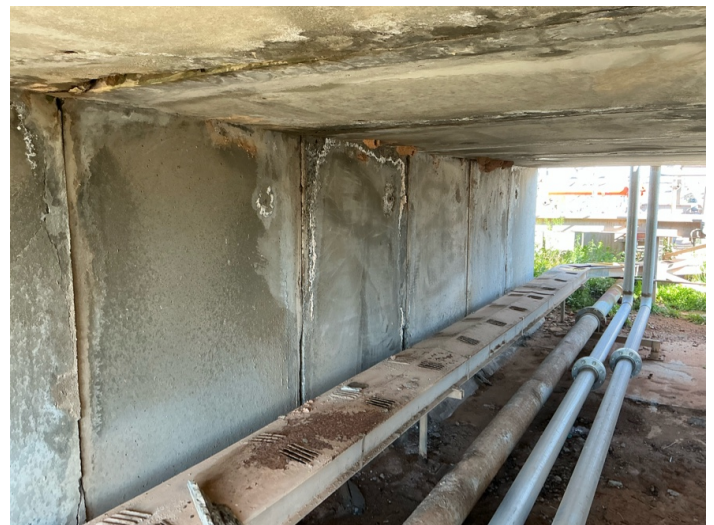
Back S0063 Santos CV5 1

- CV1, CV2, CV3, CV4 and CV6 generally recorded results within the 40.0+ MPa range.
- CV5 recorded comparatively lower results, generally within the mid-30 MPa range.
- CV7 was not tested using the Schmidt rebound hammer and therefore no estimated MPa result is reported for this culvert.
- CV8 produced significantly more variable and inconsistent rebound results than the other culverts.
- Median results recorded at CV8 ranged from approximately 20.0 MPa at the lowest test location to approximately 30.1 MPa at the highest.
- Individual rebound readings at CV8 varied considerably between strikes. This variability was observed in areas where apparent delamination was also identified and should therefore be interpreted with caution.

The remaining culverts generally produced Schmidt hammer results within the 40.0+ MPa range, with the exception of CV5, which recorded results within the mid-30 MPa range.

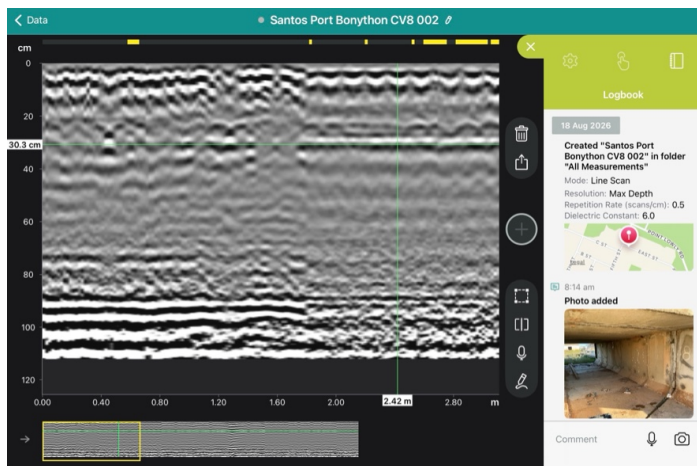
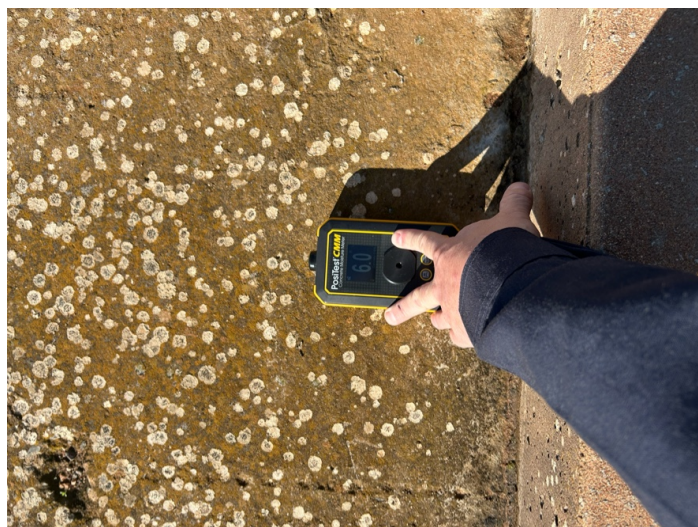
| S0061 Santos CV8 1 | | |

Of the culverts surveyed, CV8 appeared to be in the poorest overall condition based on the combined GPR observations, visible condition and inconsistent Schmidt rebound hammer results.

Apparent delamination was identified within CV8, and the substantial variation between individual Schmidt hammer impacts indicates that the concrete surface response was not uniform within the areas tested. The lower median result of approximately 20.0 MPa was also substantially below the results obtained from the majority of the other surveyed culverts.

Results can be influenced by surface condition, moisture, carbonation, aggregate, local defects and delamination. In particular, the inconsistent results recorded at CV8 may have been influenced by the apparent delamination observed within the tested areas.
